# مروری بر برخی مشکلات طراحی و اجرایی دو پروژه تونلی شرکت مهندسی ساخت و ساز هیوندای کره جنوبی

دکتر ابراهیم فرخ

انجمن تونل - ۳۰ خرداد ۹۷

## ۲- ارزیابی خصوصیات طراحی و عملکرد TBM- تونل زیر دریایی Jinhea-Geoje کره جنوبی

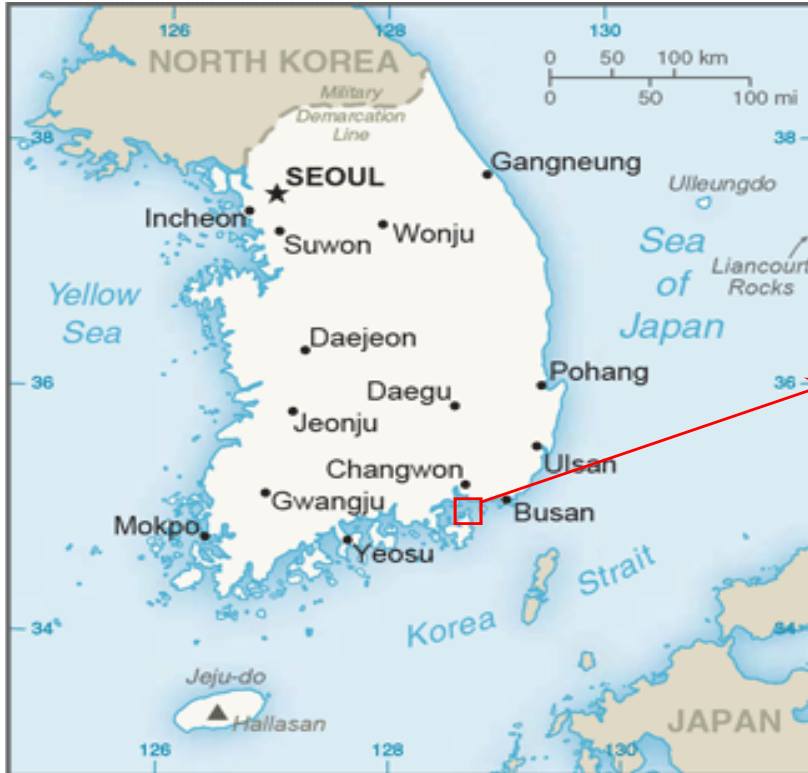
# موقعیت پروژه

- ✓ 4300 m , 3500 m
- ✓ ID/OD=2.8/3.2 m
- ✓ Depth/crown= 85 m
- ✓ Invert/water= 8.83 bar

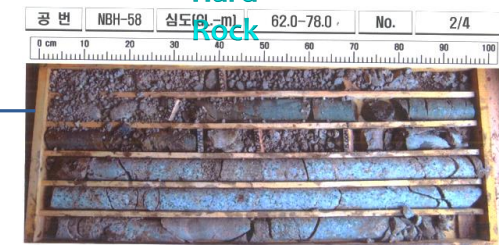
# زونهای خرد شده

Soft Rock

Hard  
Rock

Weathered Rock/Fracture Zone

As tunnel depth decreases the length of tunnel with RQD<10% increases

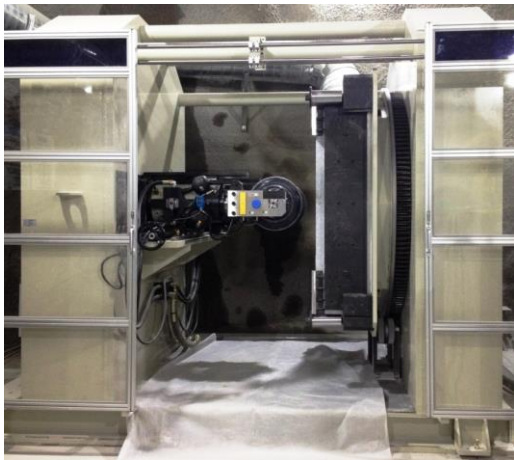
# آزمایش نفوذ-RCM

Rotary Cutting Machine Developed in HDEC

- ☐ Constant Penetration Mode
- ☐ Constant Normal Force Mode
- ☐ RPM Change Mode

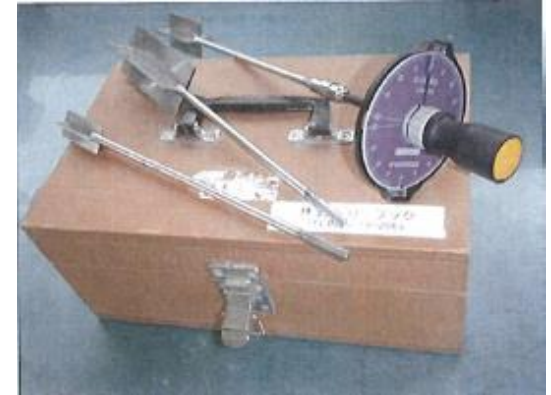
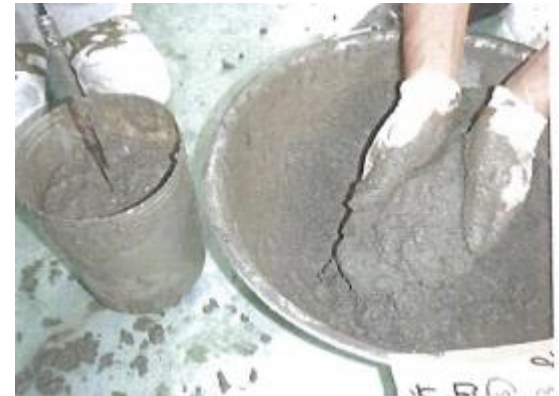
\* Ring 260: on the muck from muck car

- \* Very clumpy and sticky
- \* Anti-clay injection: 40 lit/min
- \* 5 cm slump

\* Ring 261: on the muck from discharge point

- \* Sticky
- \* Anti-clay injection: 40 lit/min
- \* 11 cm slump

\* Ring 269: on the muck from discharge point

- \* Low stickiness
- \* Anti-clay injection: 70 lit/min
- \* 16.5 cm slump

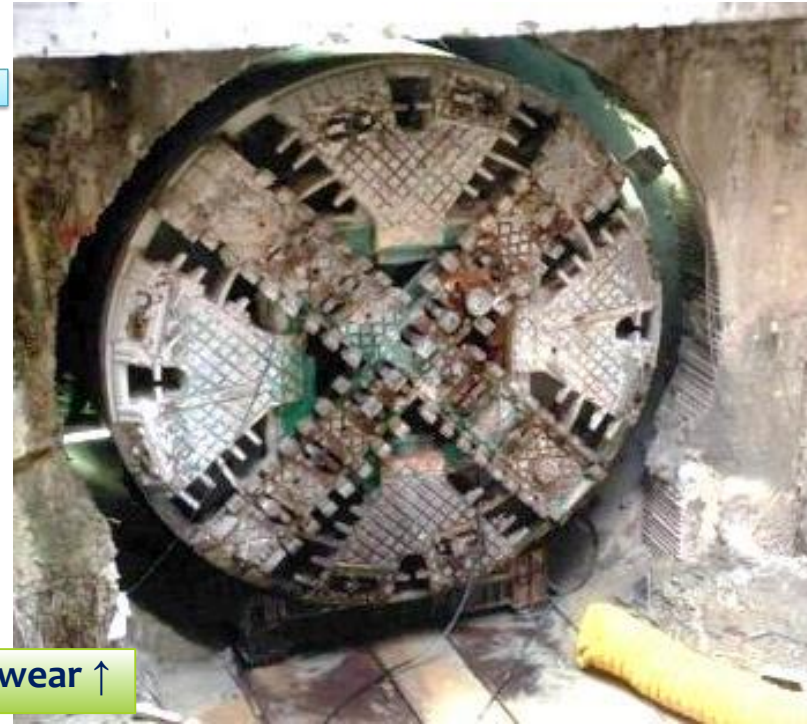
## \* Tool Wear depends on Tool Travel Length
