# NORWEGIAN HYDROPOWER TUNNELLING II

**NORWEGIAN HYDROPOWER  
TUNNELLING II**

**Publication No. 22**

**NORWEGIAN TUNNELLING SOCIETY**

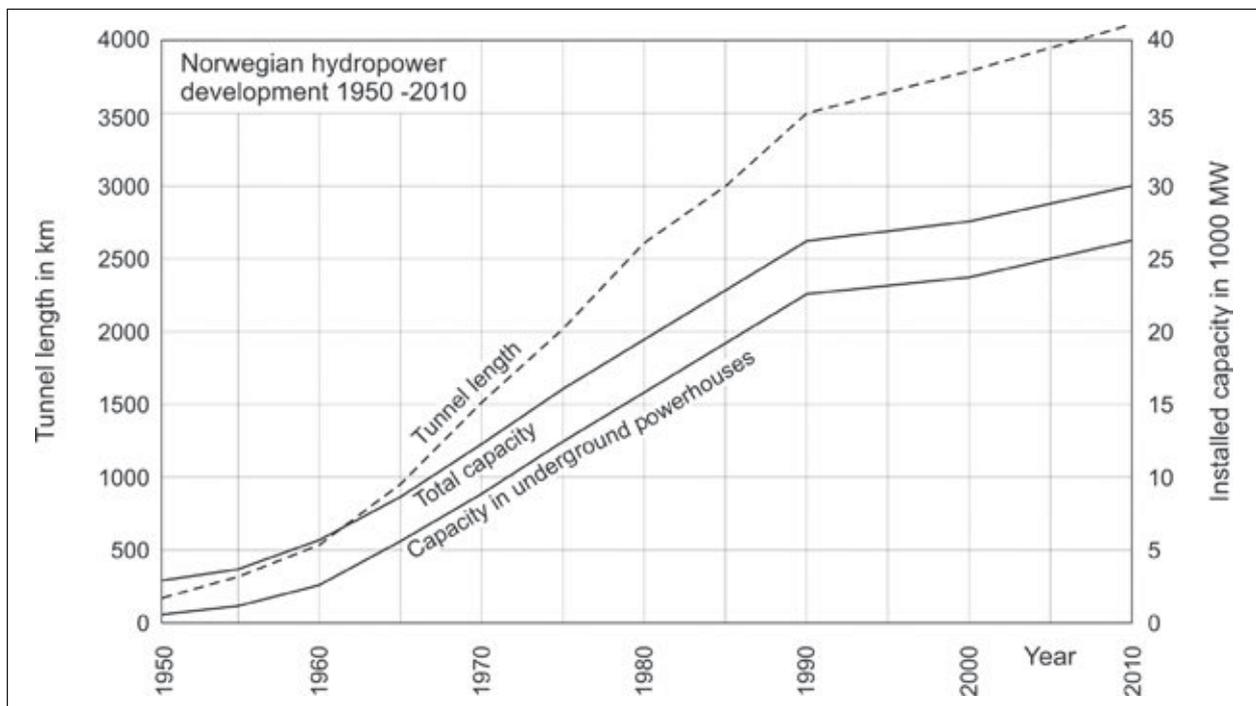
Figure 1. The development of Norwegian hydroelectric power production capacity and the accumulated length of tunnels excavated for the period 1950 -1990.

More than 99% of a total annual production of 140 TWh of electric energy in Norway is generated from hydropower. Figure 1 shows the installed production capacity of Norwegian hydroelectric power stations. It is interesting to note that, since 1950, underground pow-

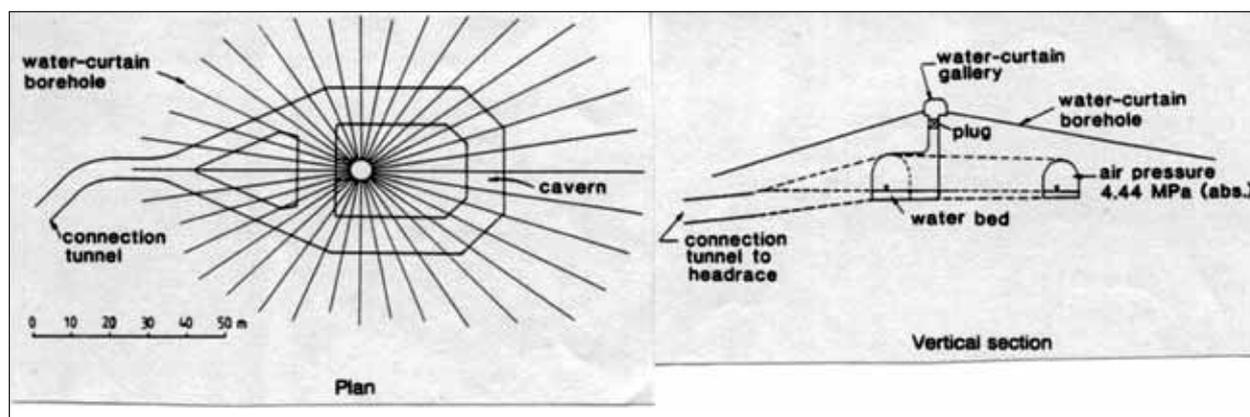
Figure 6. Air cushion surge chamber with water infiltration curtain at Torpa (Kjølborg, 1989)

For the tenth chamber, at Torpa, a water curtain was included in the original design, and installed from a designated gallery above the chamber as shown in Figure 6. During construction the rock mass around the doughnut shaped chamber was pre-grouted. Extensive rock stress measurements were performed with a variation of results; some indicated the minimum rock stress to be as low as the storage pressure at 4.4MPa (Kjølborg, 1989). Without the infiltration running, the leakage rate was 400Nm<sup>3</sup>/h; with the curtain in operation at 0.2MPa above the air pressure, there is no measurable leakage.

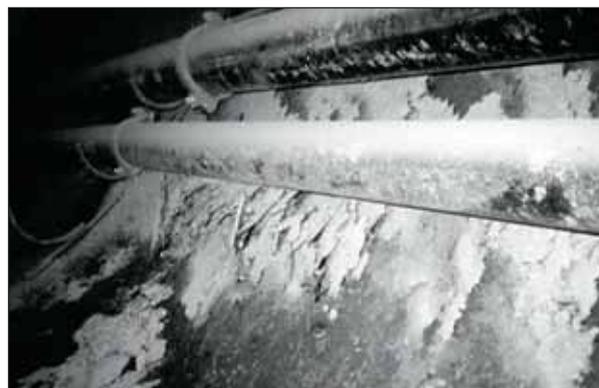
Figure 7. “Crazing” due to weathering in amygdaloidal basalts in the Transfer tunnel in Lesotho.

the invert where water from the boring process flows constantly. A phenomenon known as “crazing” was observed. This is a form of rock deterioration or weathering which occurs in highly amygdaloidal basalts. Studies revealed that this is caused by the reaction of two mineral types occurring in the highly amygdaloidal basalt. When in contact with water, smectite minerals in the characteristic amygdales or matrix of the basalt swell causing the rock face to desintegrate, see Figure 7.

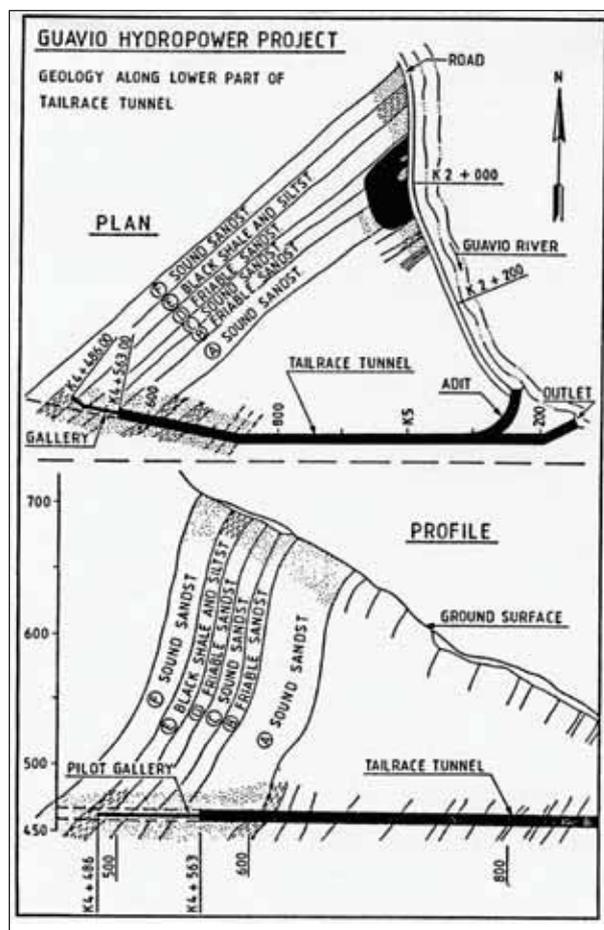
Figure 8. Geology along the lower part of the Guavio tailrace tunnel.

old, - see Figure 8. The formation is dominated by aeolian sandstones, some of them with a rather high porosity and low diagenesis, which means that they are poorly cemented and have a uniaxial compressive strength as low as in the order of 10-20 MPa. During the drilling of a probe hole from the centre of the tunnel face, water under high pressure was struck at a depth of 25 m. The leakage increased rapidly to 7 l/sec (420 l/min), and fine sand started coming out of the borehole. During the following day two slides occurred. From these two areas up to 40 l/sec and 70 l/sec of water was pouring out for a couple of hours. After one day a total 350 m<sup>3</sup> of sand had been flushed into the tunnel, and the tunnel face had moved 4 m from Station 4+567 to Station K4+563. It was then decided to block the tunnel face with concrete.

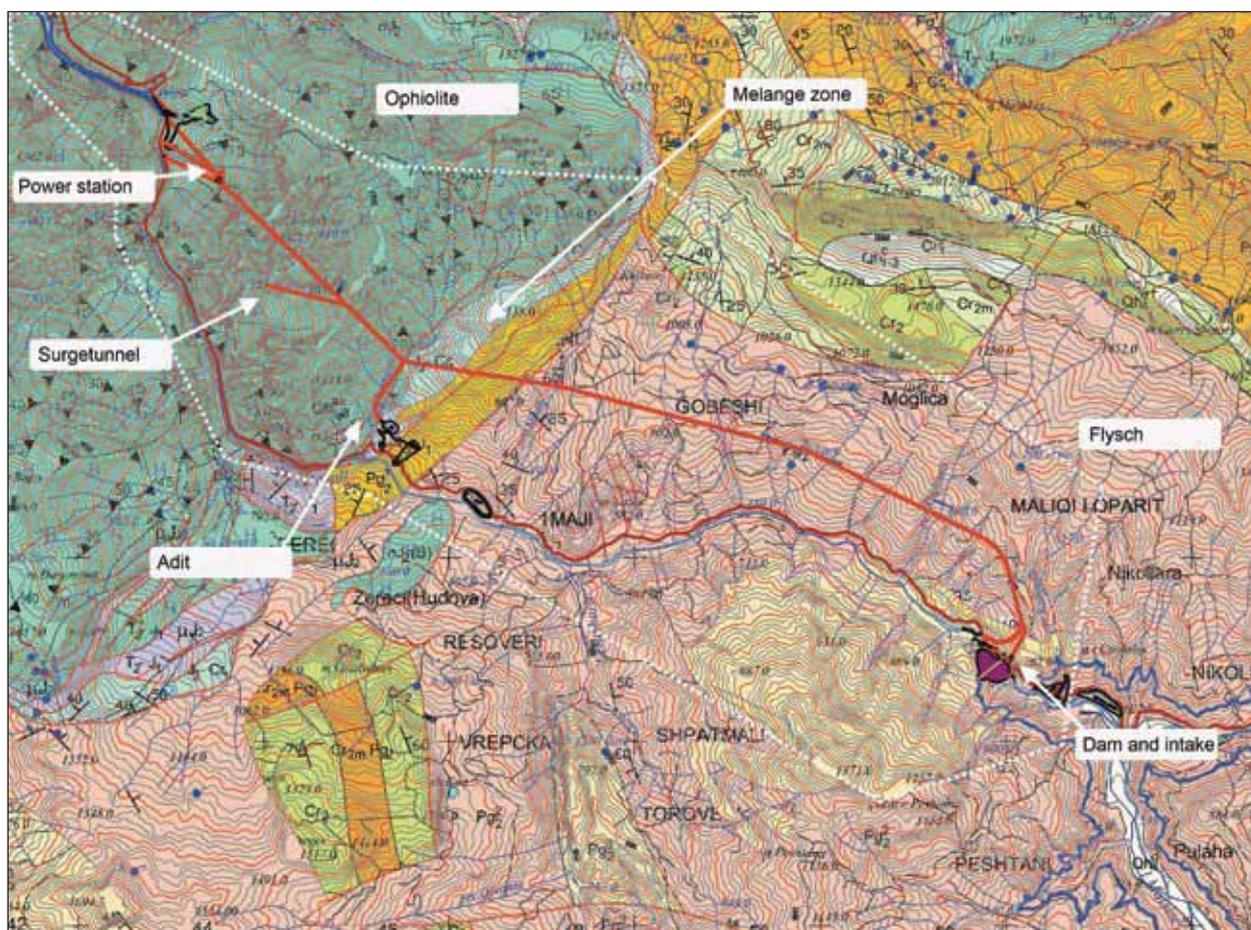
Figure 3: Excerpt of the geological map of Albania with the tunnel system shown in red

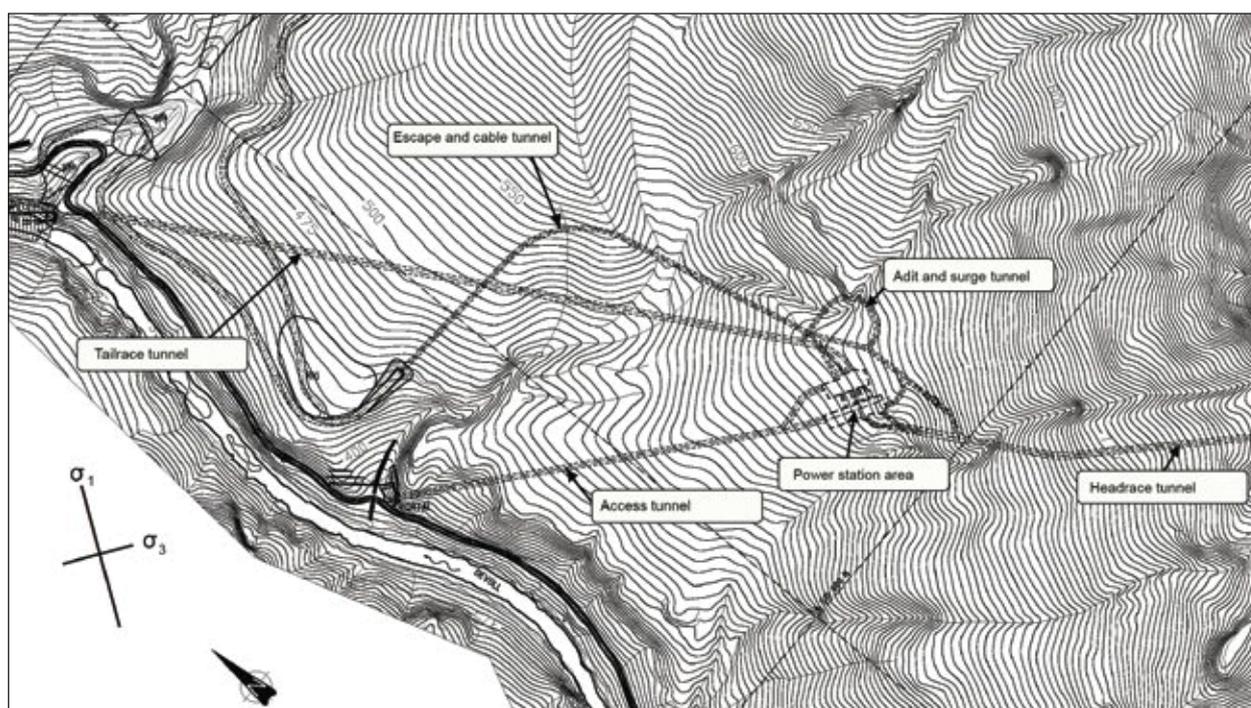
Figure 6: Power station layout and stress field directions

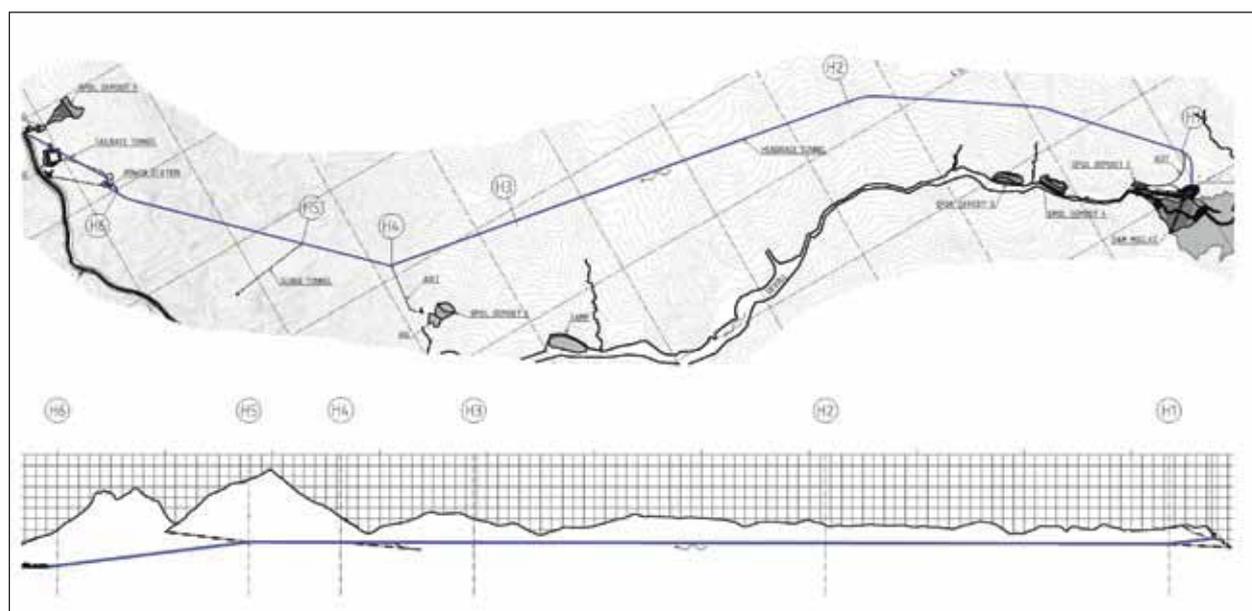
Figure 7: Layout of hydropower scheme - waterway highlighted blue

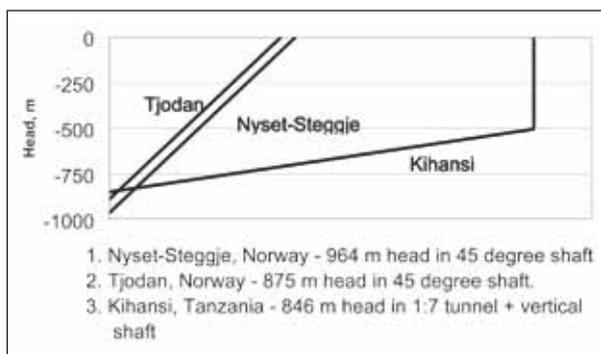
Figure 2: Highest water heads in unlined tunnels / shafts.

An unlined, low-gradient water tunnel with as high head as 850 m head had not been constructed before, anywhere in the world. In 2 other hydropower plants, Tjodan and Nysset-Steggje in Norway higher heads were obtained in 45° inclined shafts, 875m and 964m respectively. The design at Kihansi is more vulnerable in regard to leakages, as the high head section in a tunnel with inclination 1:7 is longer than in a 45° shaft, shown schematically in figure 2.

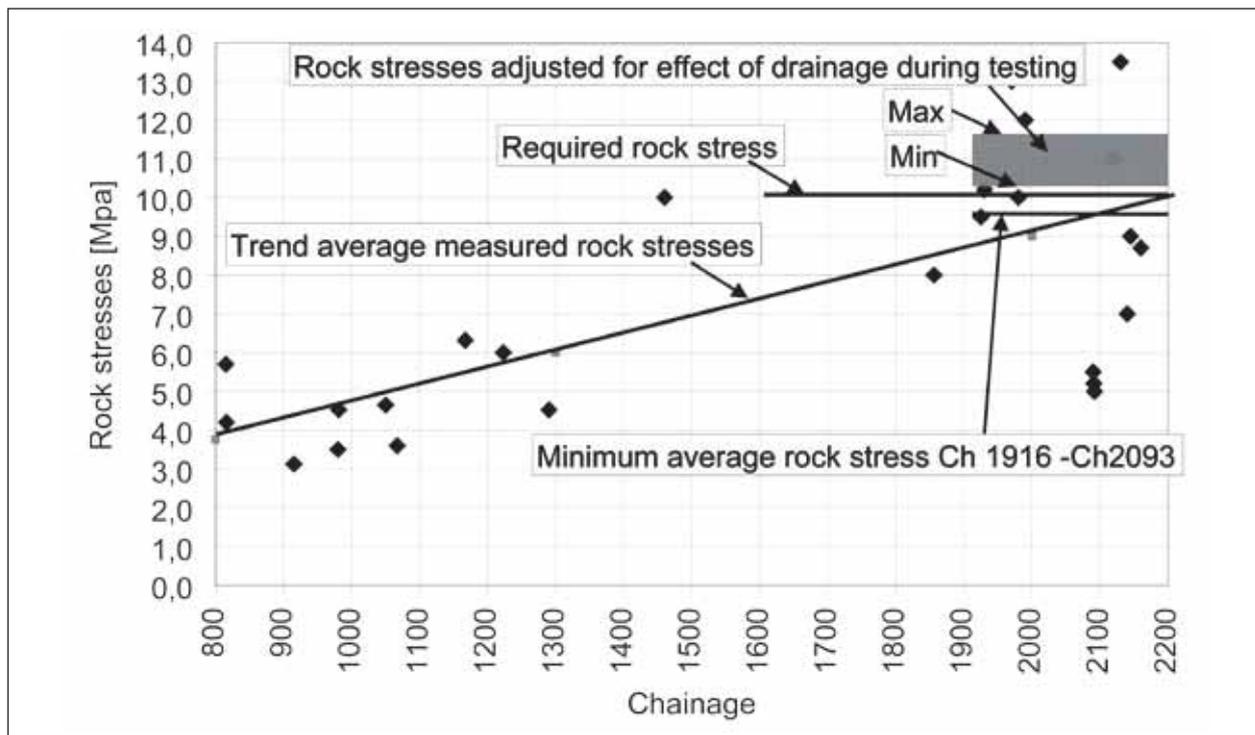
Figure 3: Measured rock stresses, with adjustment for drainage effect

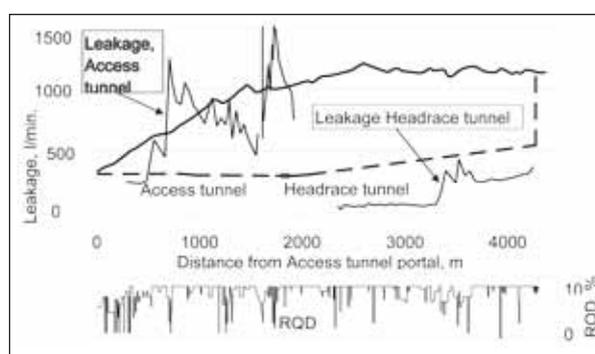
Figure 4. Leakage from access tunnel and headrace tunnel during excavation, measured weekly at portals as tunnel face pro-ceeded

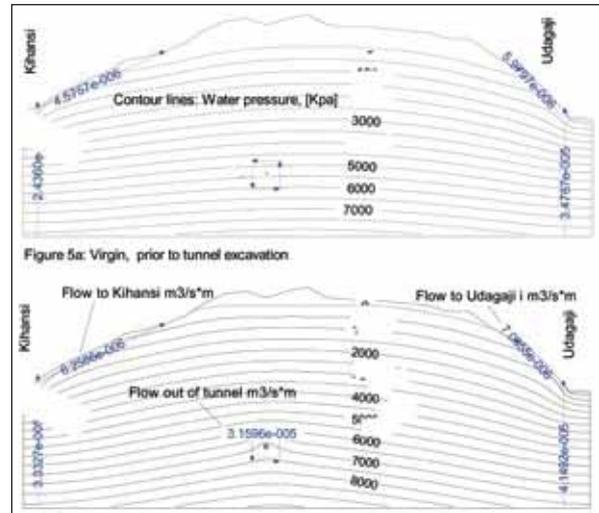
Figure 5: Water pressure lines in a cross-section upstream of the plugs prior tunnel excavation and after completed filling.

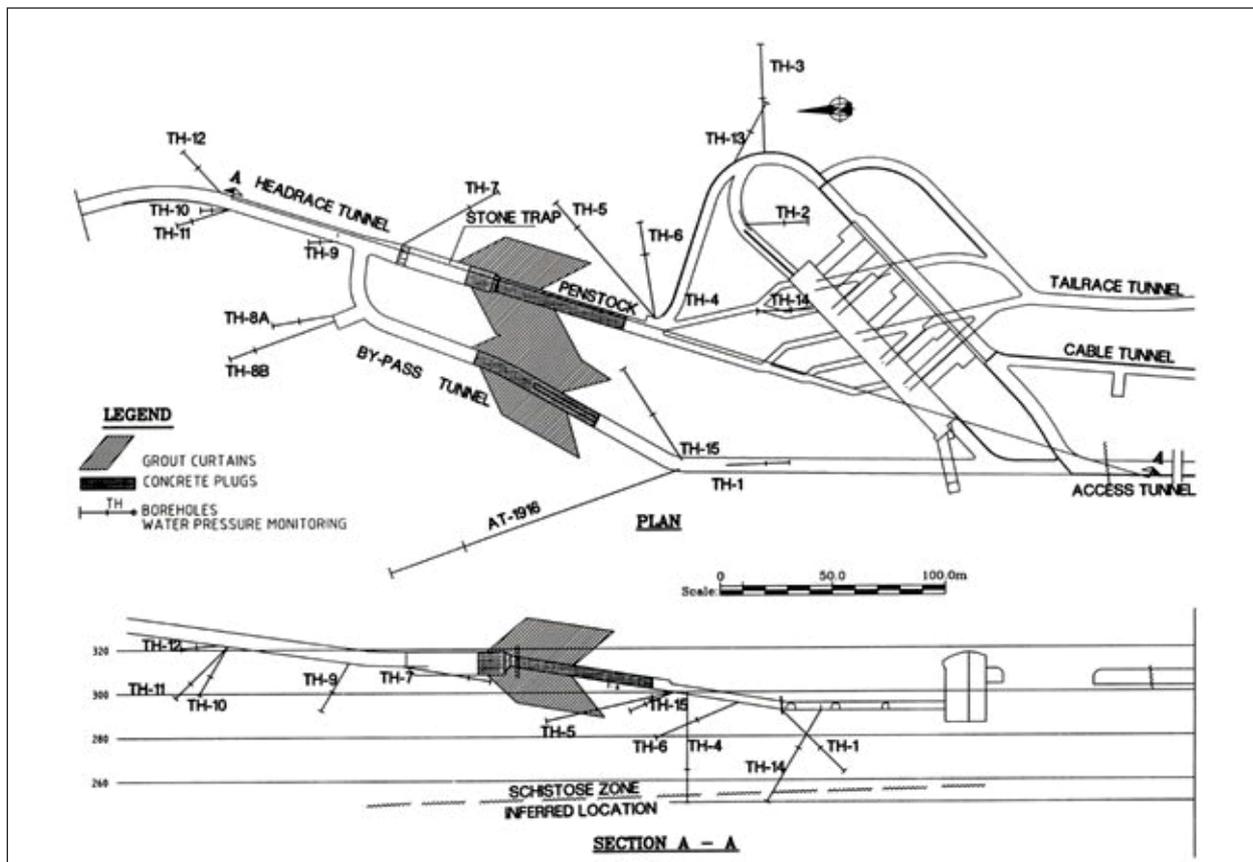
Figure 6: Layout of tunnel and monitoring system

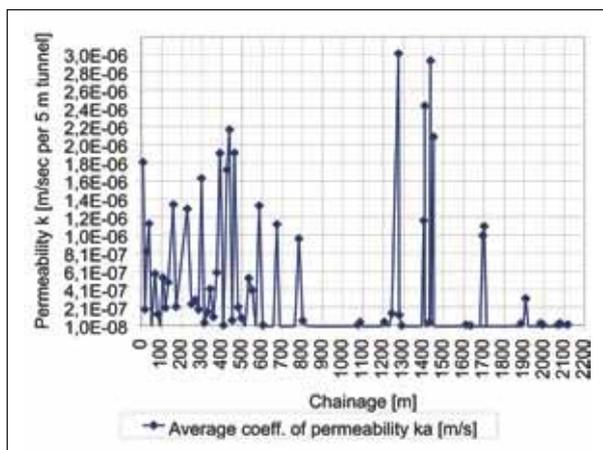
Figure 7: Permeability of rock perpendicular to the tunnel axis, and grout take for grouting at face. Coefficient of permeability  $k$  is calculated based on water pressure tests /water inflow in soundings and ahead of face

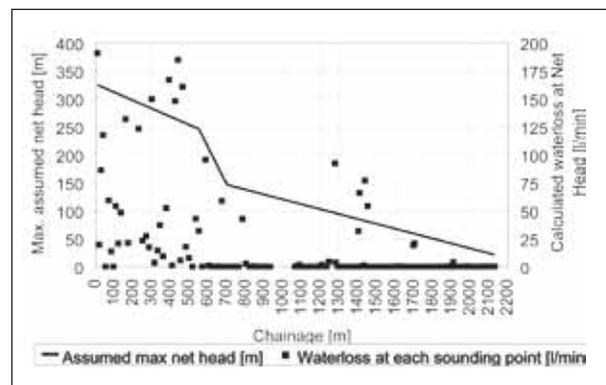
Figure 8: Estimate of water leakage from headrace tunnel, cal-culated on the basis of the permeability determined at the soundings ahead of face.

An estimate of expected water leakage out of the head-race tunnel was made using the permeabilities, esti-mated on the basis of the soundings, taking the future net head along the tunnel into account. The estimated leakage at each joint system crossed by the soundings as well an estimated net head curve are shown in Figure 8. Economic analyses were made to obtain parame-ters for reducing leakage from the headrace tunnel. The net present value of production losses at the Ki-hansi project

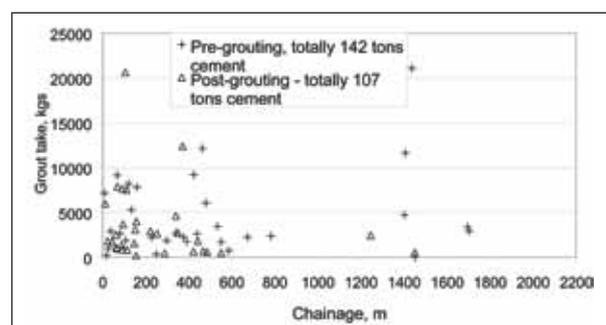
Figure 9: Grout takes in headrace tunnel

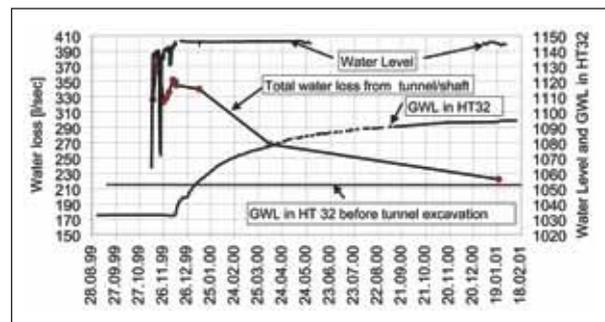
Figure 14: Total outflow from Shaft and Headrace tunnel just after and up to 4 months after filling was completed. Reservoir water level and water level in HT32 are shown for reference.

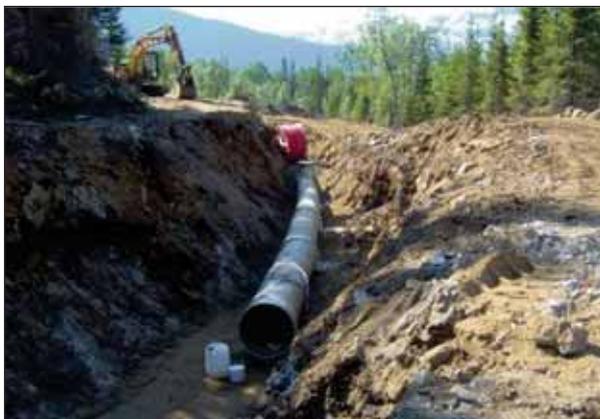
Figure 1. Installation of penstock in ditch

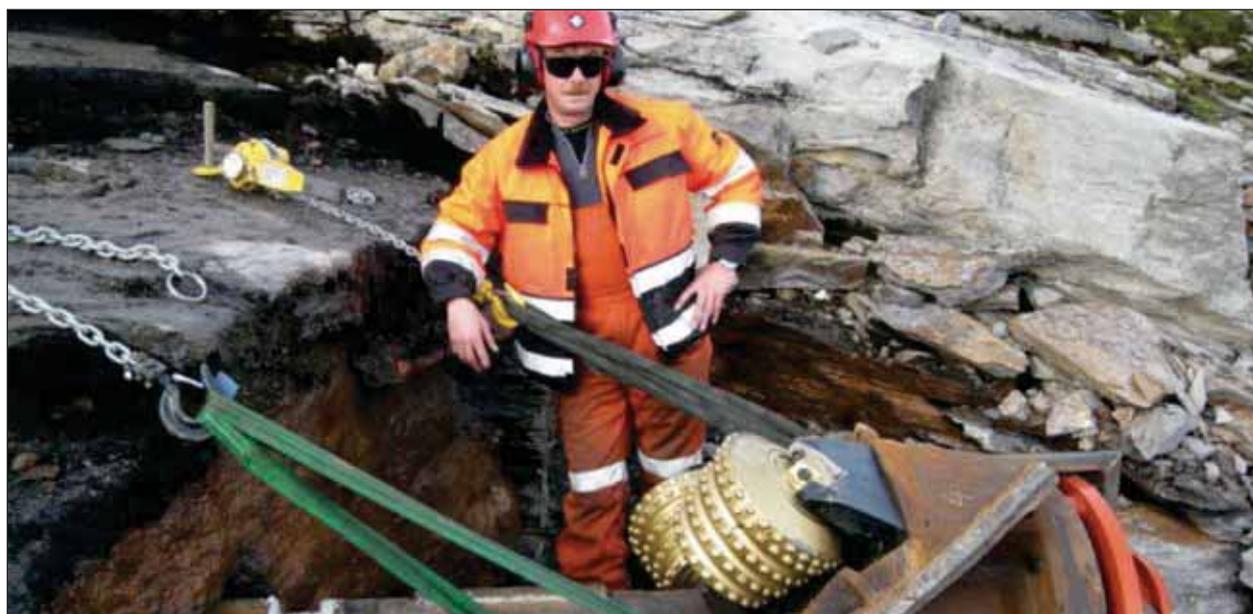
Figure 5. Raise drilling. Ready for reaming the shaft

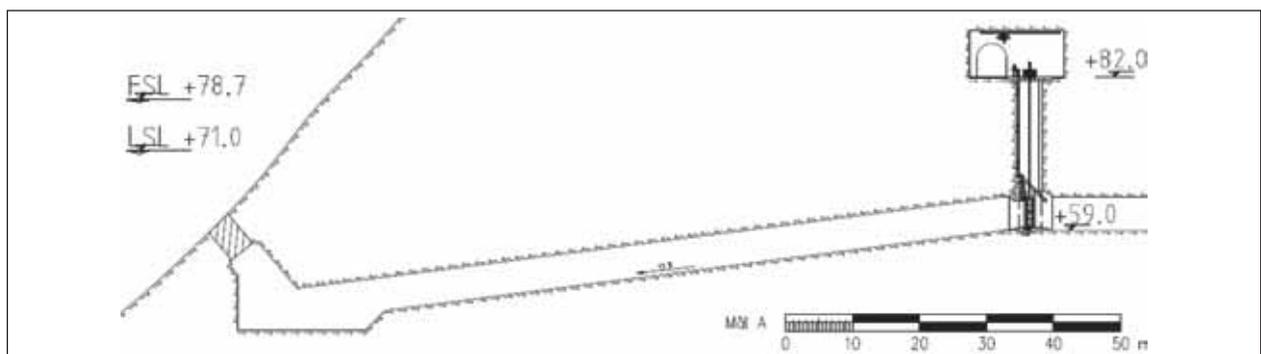
Figure 3 Geometric layout of intake at Sisimiut.

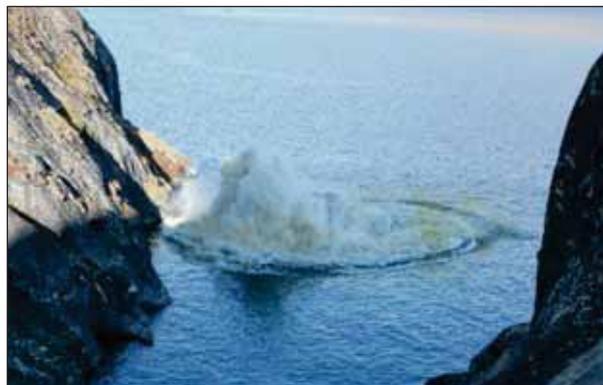
Figure 6 Picture showing the reservoir approximately 8 seconds after detonation.

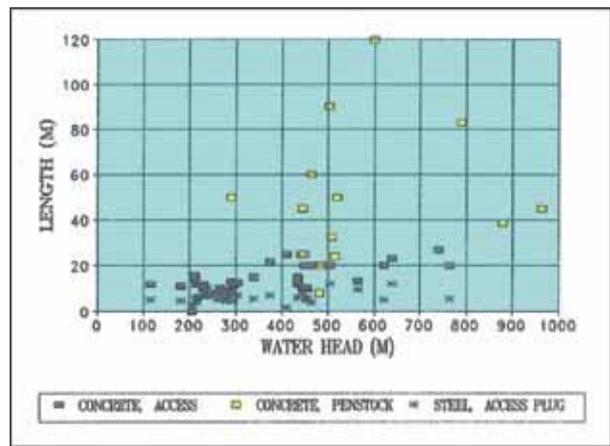
Figure 3 - Length of steel lining and concrete structure vs. static water head.

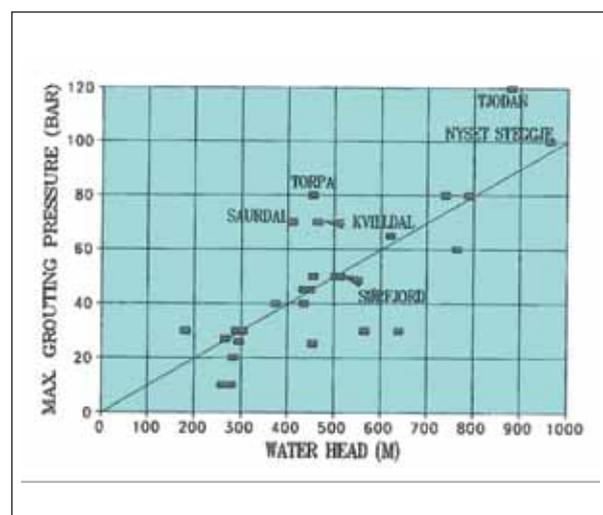
Figure 5 - Grouting pressure vs. static water head.

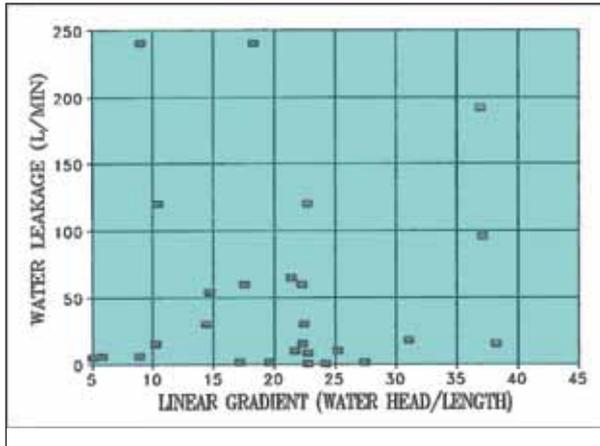
Figure 6 - Leakage vs. linear hydraulic gradient.

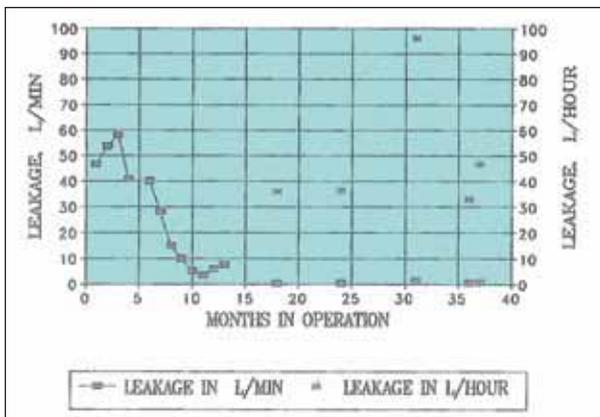
Figure 7 - Leakages at Tjodan (880 meter water head) 1984-1987.

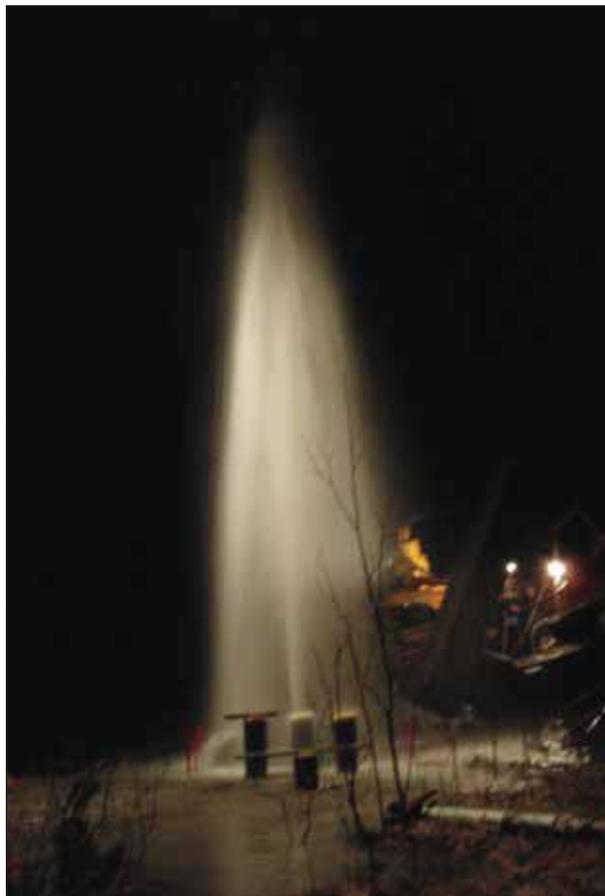
Figure 2 - Drilling into the water filled tunnel.

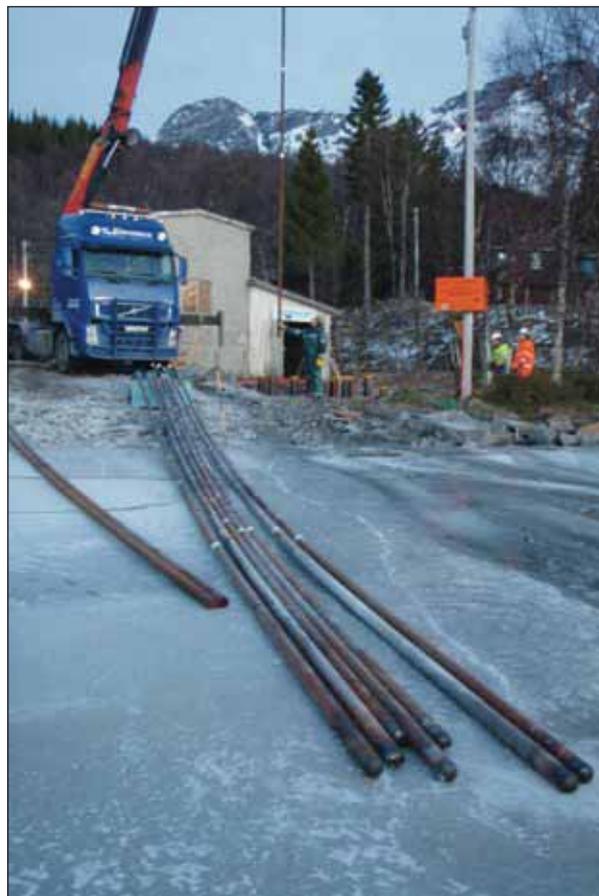
Figure 3 - Freezing pipes ready for installation. Gatehouse in the background.

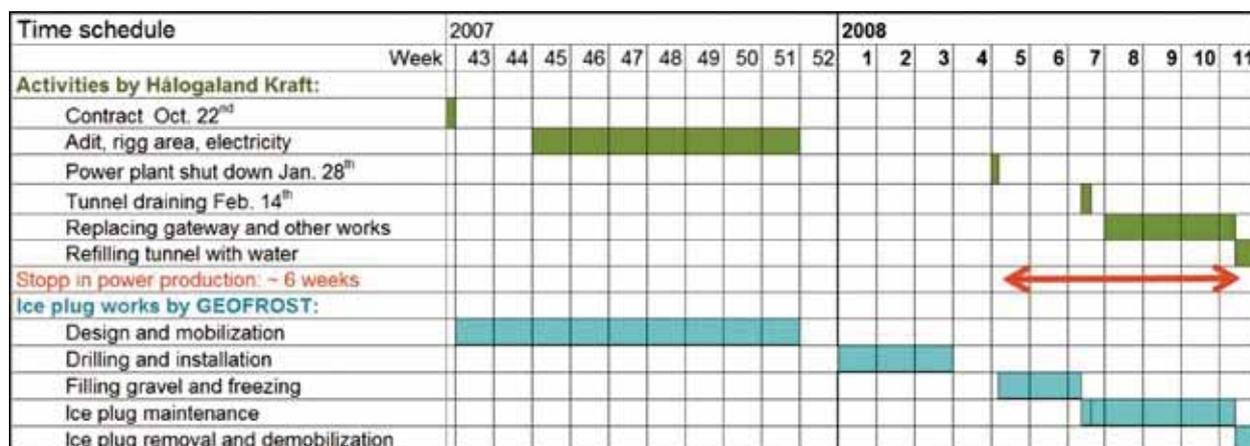
Figure 4 - Timeconsumption for different project activities.

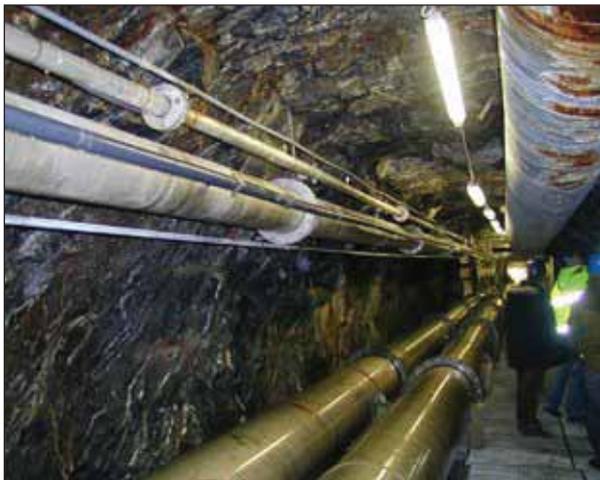
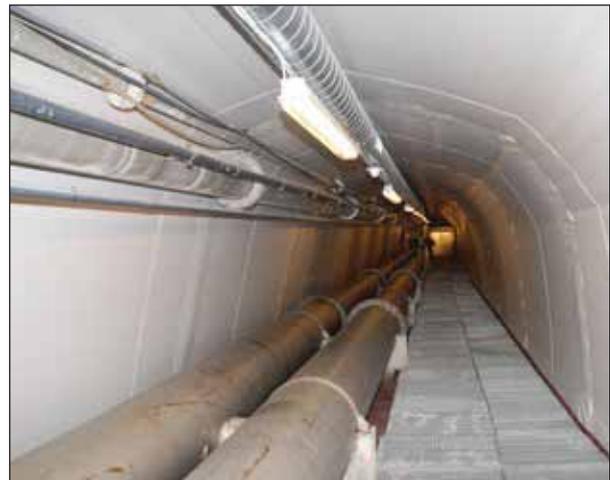
Figures 1 and 2: The picture to the left shows a typical situation in a pipe access tunnel where you have a wet and humid environment that gives corrosion problems to steel pipes and electrical equipment. To the right we see a picture of a complete different result after the installation of WGTS. The humidity is now under control and the life time for the assets has increased dramatically.

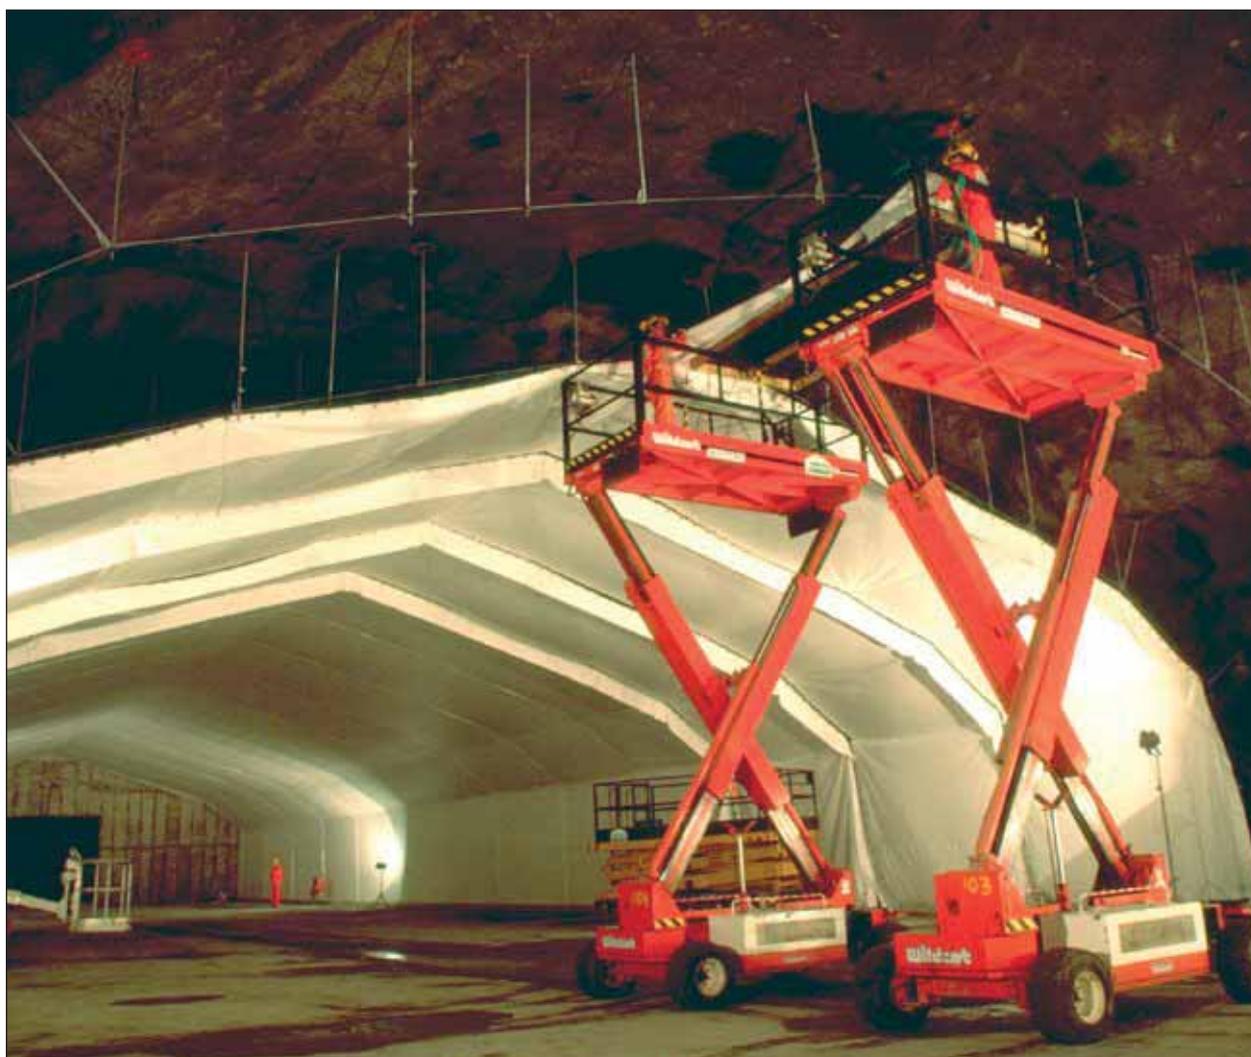
*Figure 3 shows the installation of the WGTS in a rock cavern. From a final product at the far end to the on going installation work, using electrical driven lifts in the front. At the top of the picture we can see the rock bolts and the steel wire rope running between the rock bolts.*

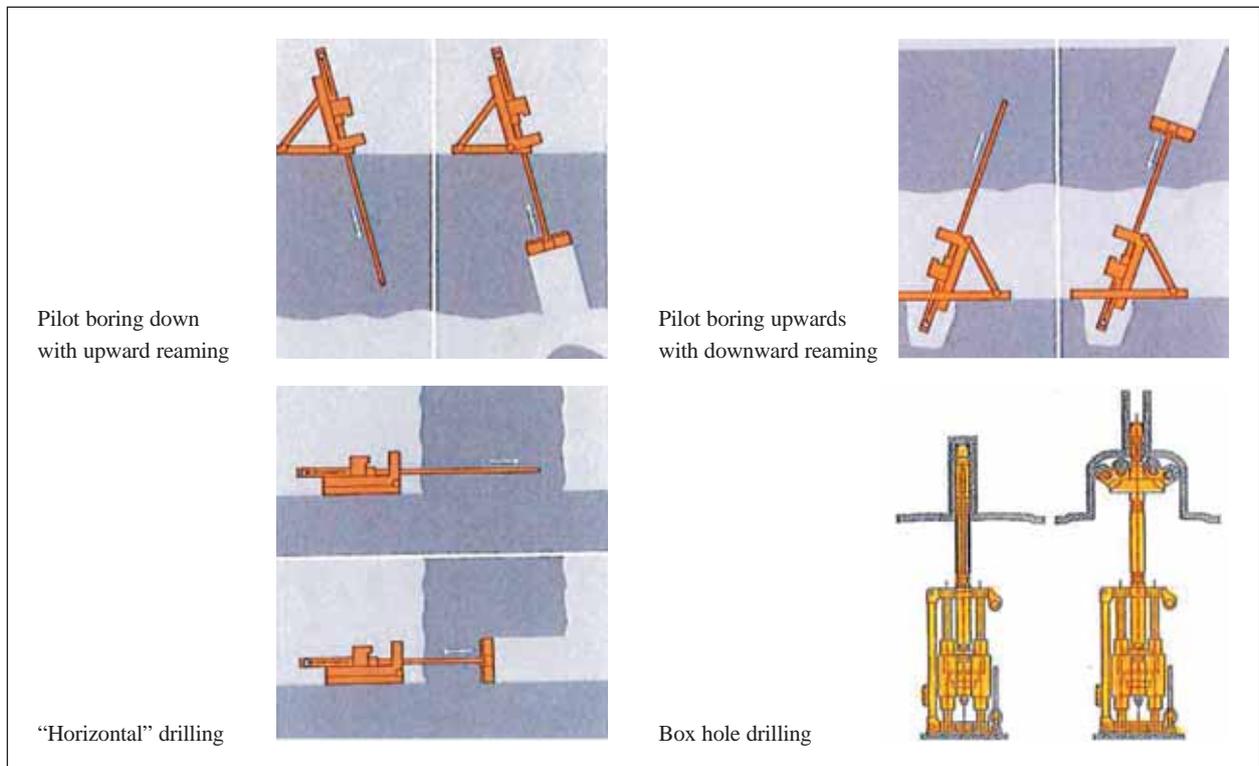
Figure 1 – Examples showing different use of the raise drilling

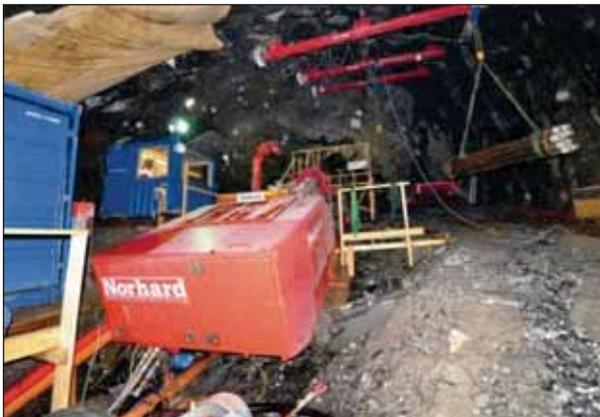
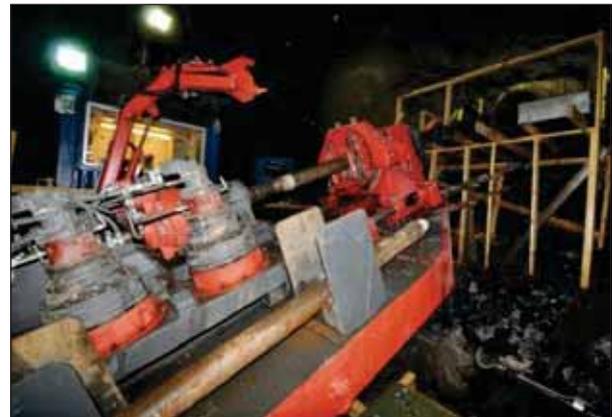
Figure 5: NDL700HR in operation at Muiodejohka Power plant

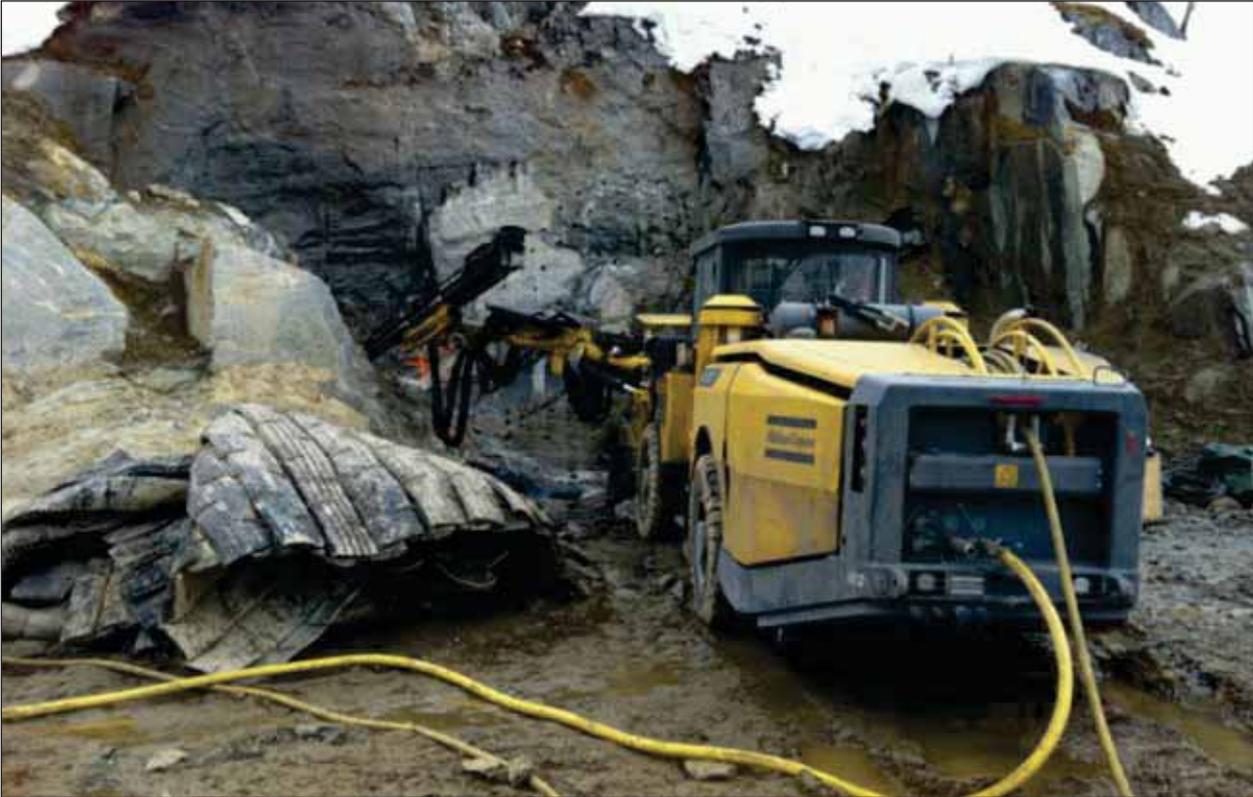
Figure 8 Securing and spiling

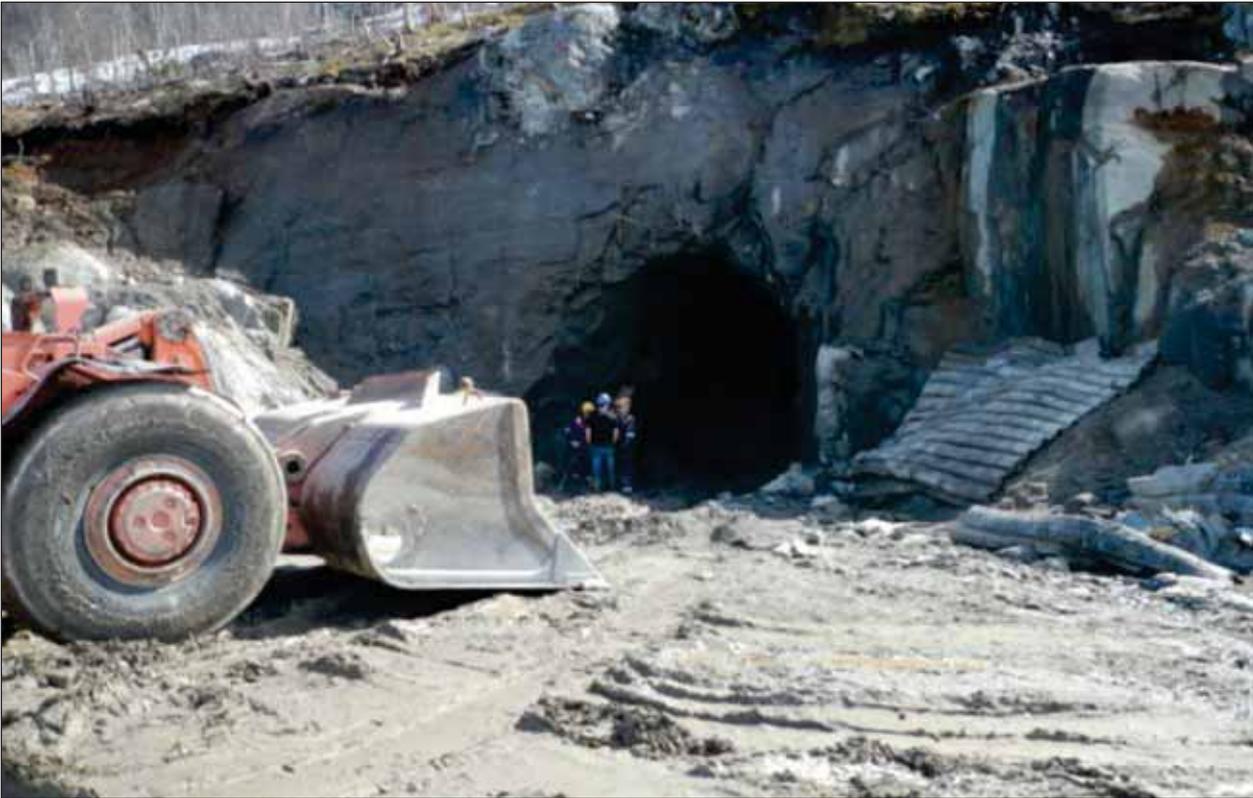
Figure 9 20 m tunneled

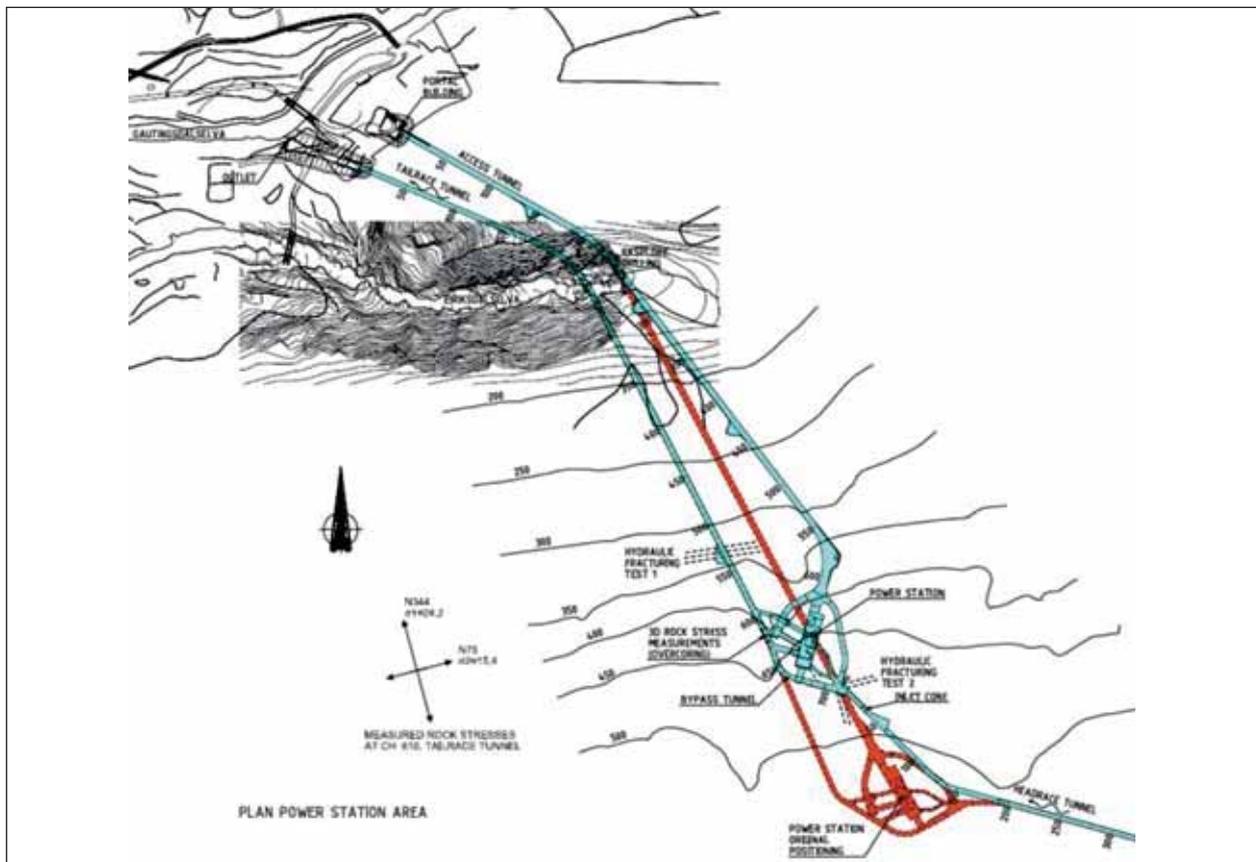
Figure 2. Original and final location of the power station area.

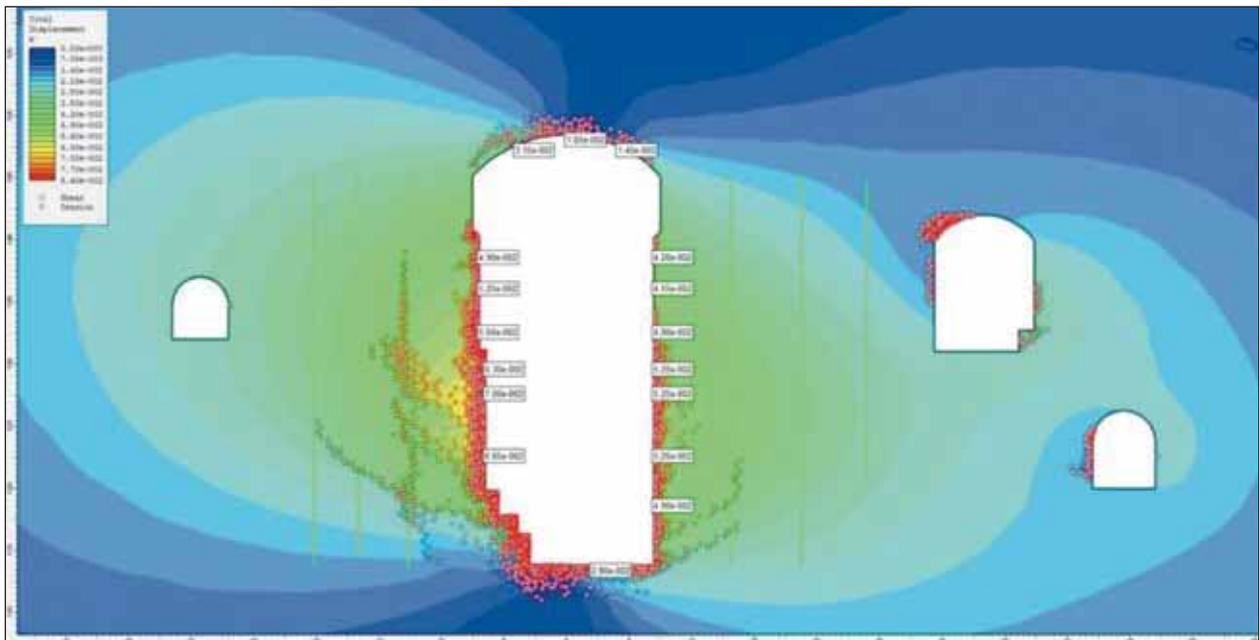
Figure 4 presents the results of deformations of the caverns rock surface and the depth of the failure zone.

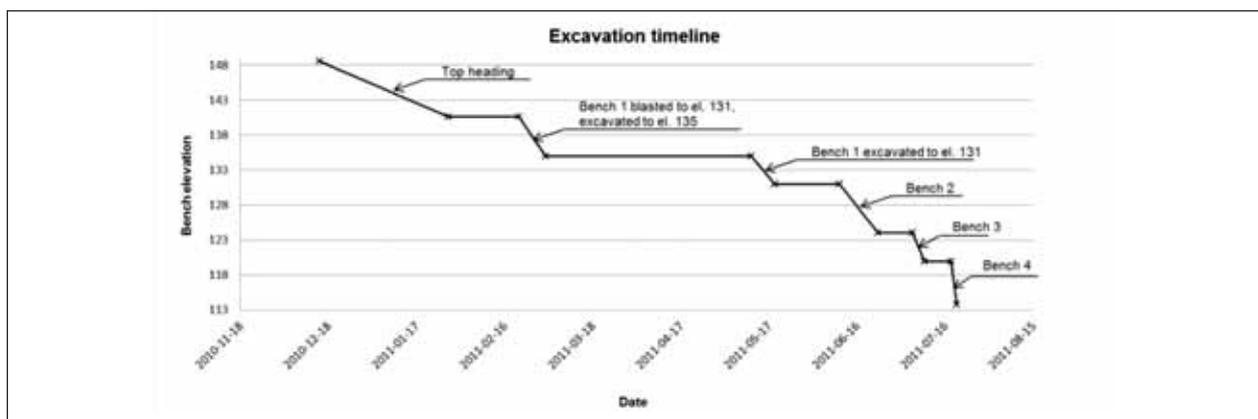
Figure 8. Excavation progress of the cavern with time

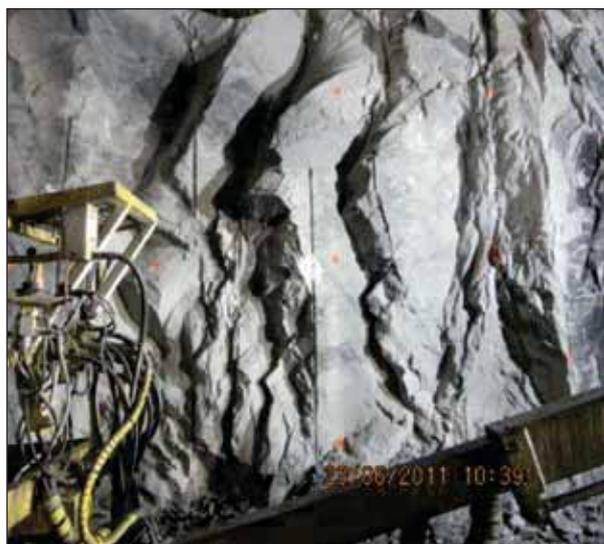
Figure 13: Shows secondary joint sets sub-parallel to the walls, that formed after blasting due to high rock stresses.
