# NORWEGIAN HYDROPOWER TUNNELLING II

**NORWEGIAN HYDROPOWER  
TUNNELLING II**

**Publication No. 22**

**NORWEGIAN TUNNELLING SOCIETY**

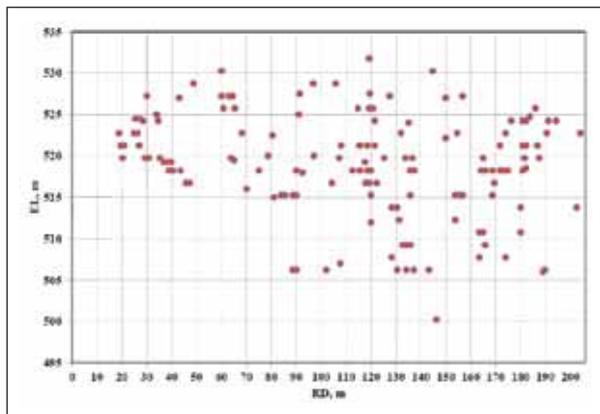
Figure 2. Location (red dots) of failed rock bolts on the upstream (U/S) wall of the machine hall cavern (Naik et al., 2011a). EL: Elevation (m); RD: position along the cavern (which is approximately 200 m long).

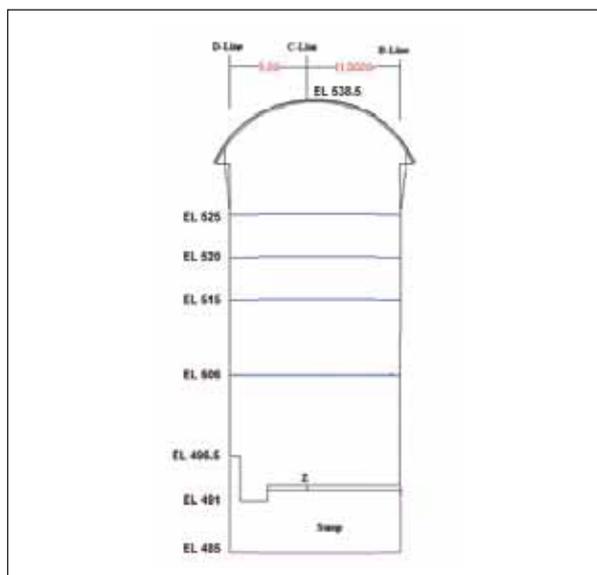
Figure 3. Section of the Machine Hall Cavern, showing general geometry (dimensions and elevations are in meter) and the locations where convergences were measured (Naik et al., 2011b).

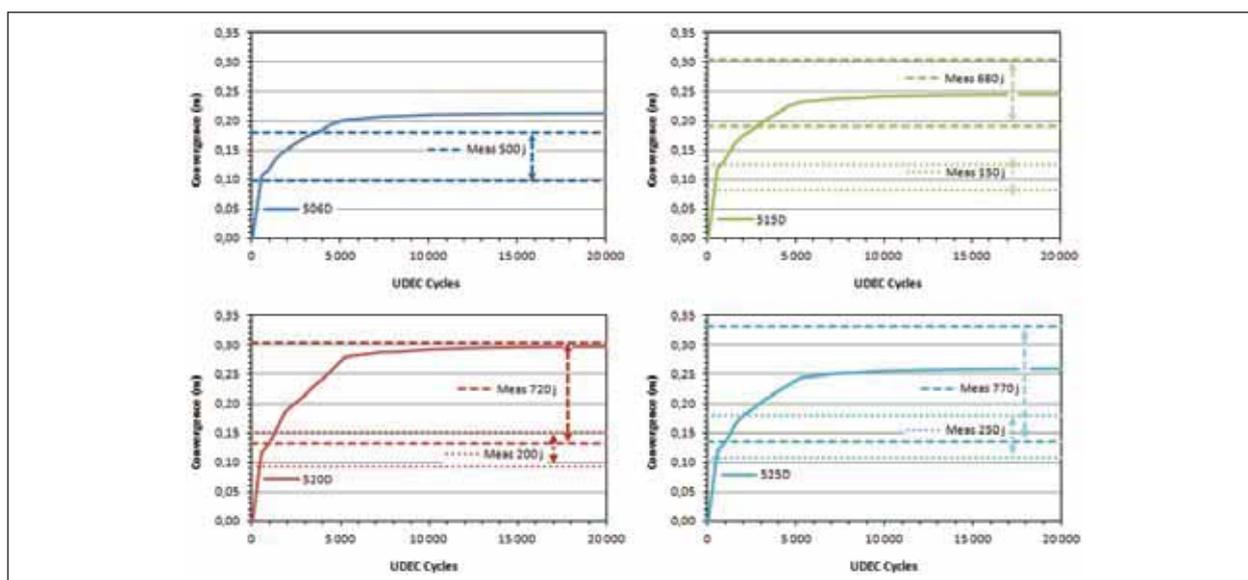
Figure 4. Comparison between convergence measurements (dashed lines; maximum and minimum convergence measured at one or two dates, at different positions along the tunnel) and simulated movements (solid line) for different elevations in the cavern.

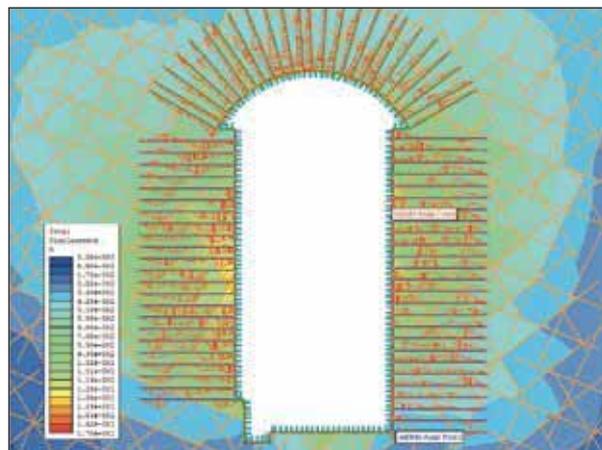
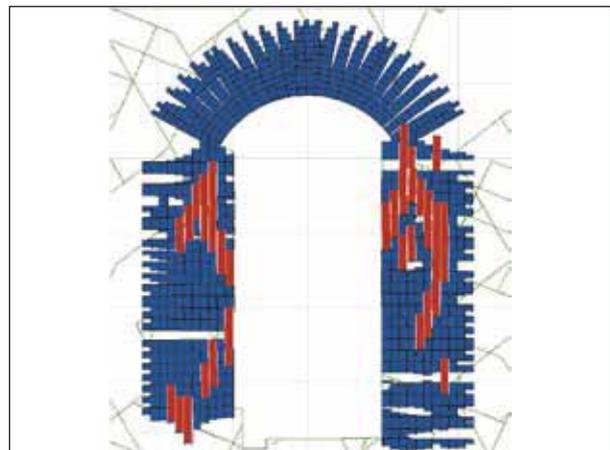
Figure 6. Maximum axial strength on bolts on the walls and on the crown of the excavation, obtained from simulations with Phase2 (left; the minimal and maximal values are indicated in blue and red respectively) and UDEC (right; failed bolt segments are indicated with a red line).

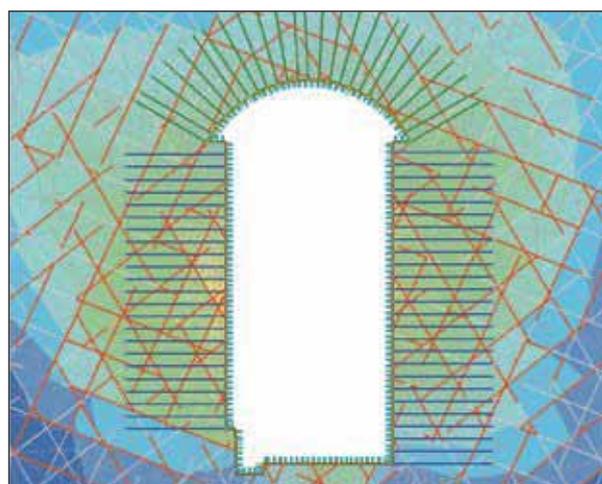
Figure 7. Joints in red are those opened by movement according to the simulations carried out with Phase2. It appears that bolts may be a bit too small and do not reach the area unyielded.

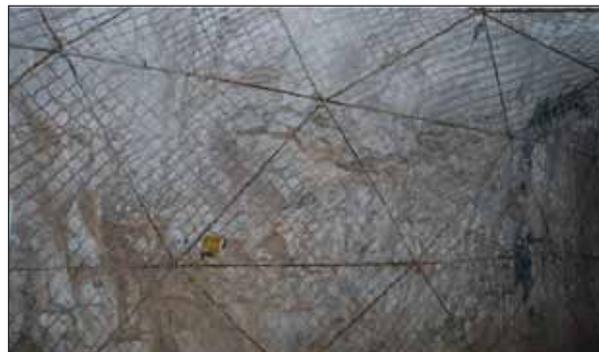
Figure 9. Mesh and lacing.

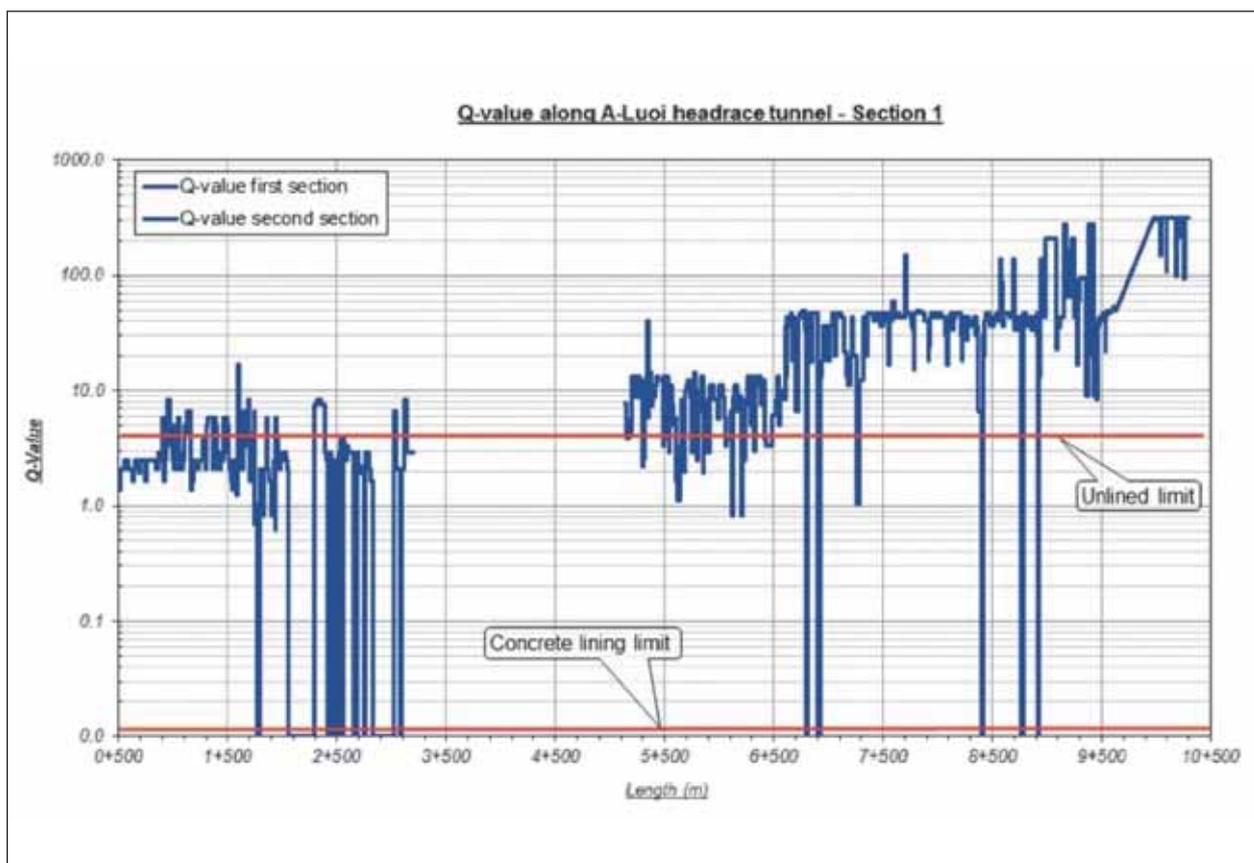
Figure 3 - Q-value distribution along the headrace tunnel of the A-Luoi HPP.

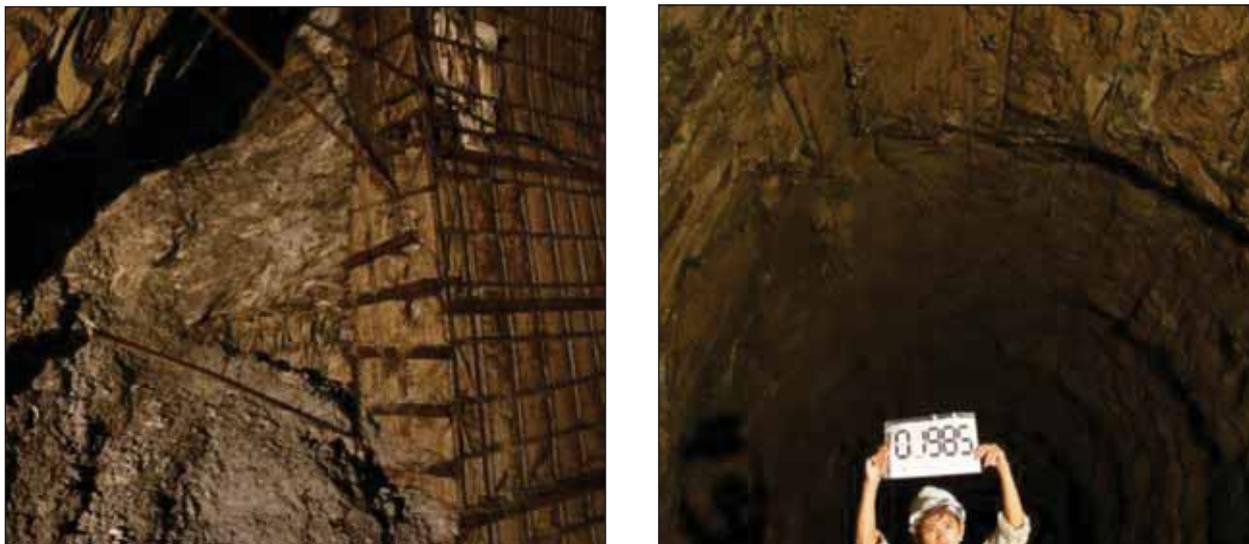
Figure 4 - Typical “Extremely Poor” (left hand side) and “Fair” (right hand side) rock mass conditions.

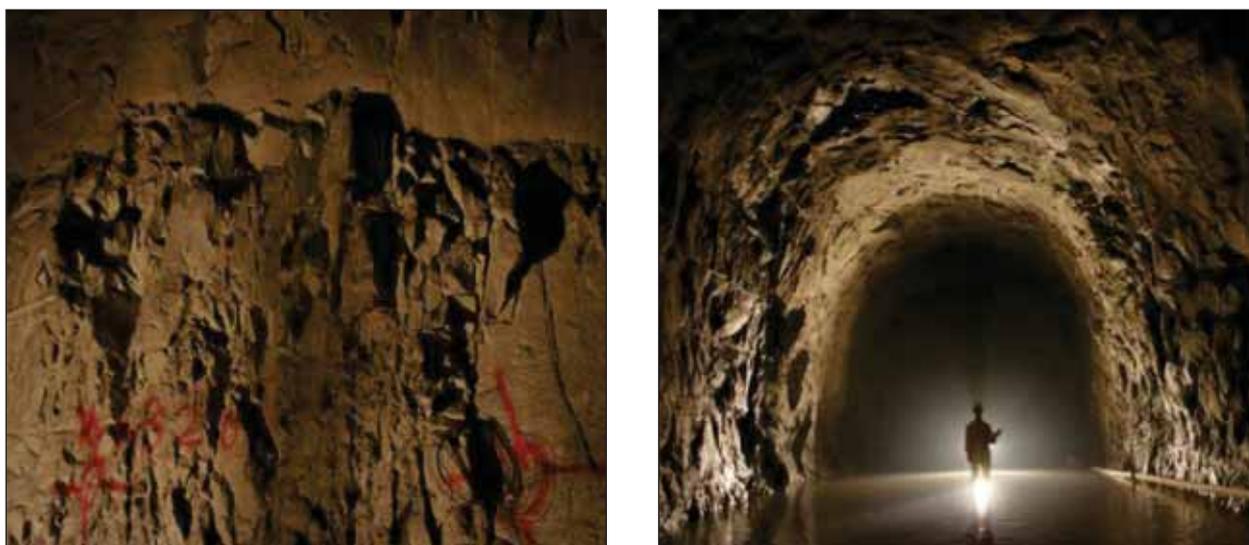
Figure 5 - Typical “Crushed zone” (left hand side) and “Extremely Good” (right hand side) rock mass conditions.

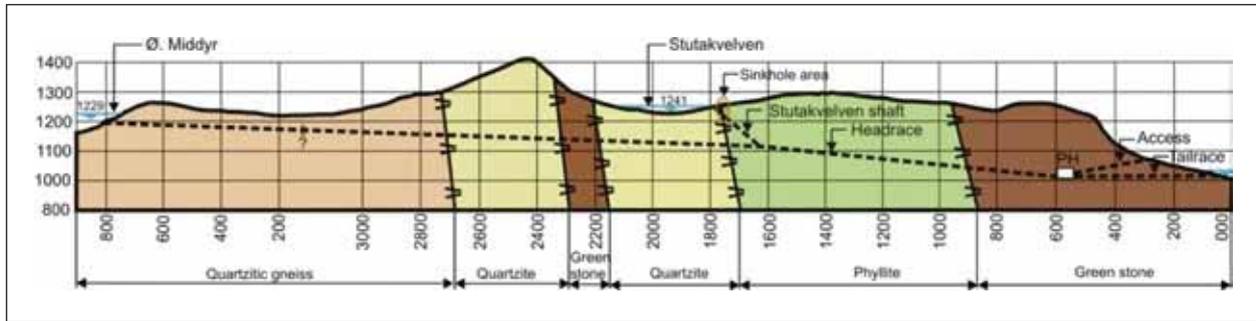
Fig. 1 - Longitudinal profile and geological set-up along the Svandalsflona (Panthi, 2012)

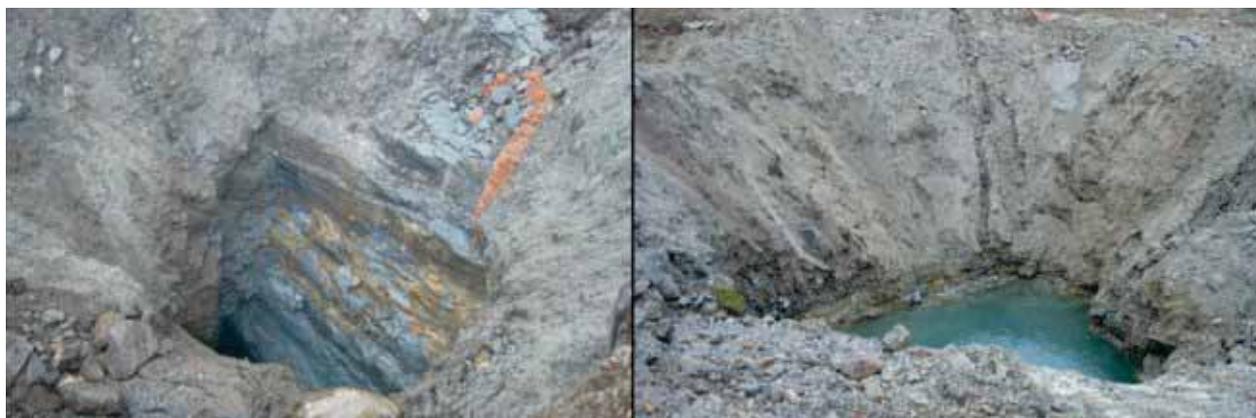
Fig. 2 - Sinkhole nearby Stutakvelven intake gate house in fully drained (a) and fully water filled (b) conditions (Courtesy: Norsk Hydro).

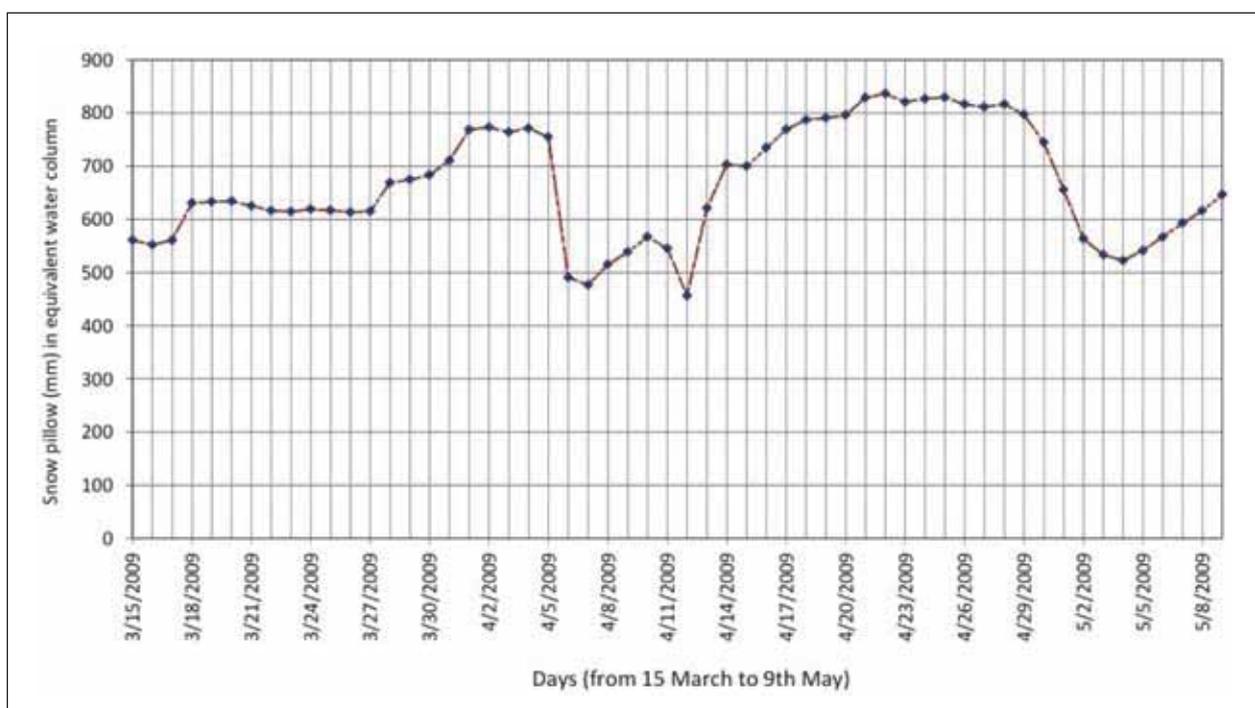
Fig. 3: Daily snow pillow in equivalent water column at the Kaldevatn from 15th March to 9th May 2009 (Panthi, 2009 and 2012).

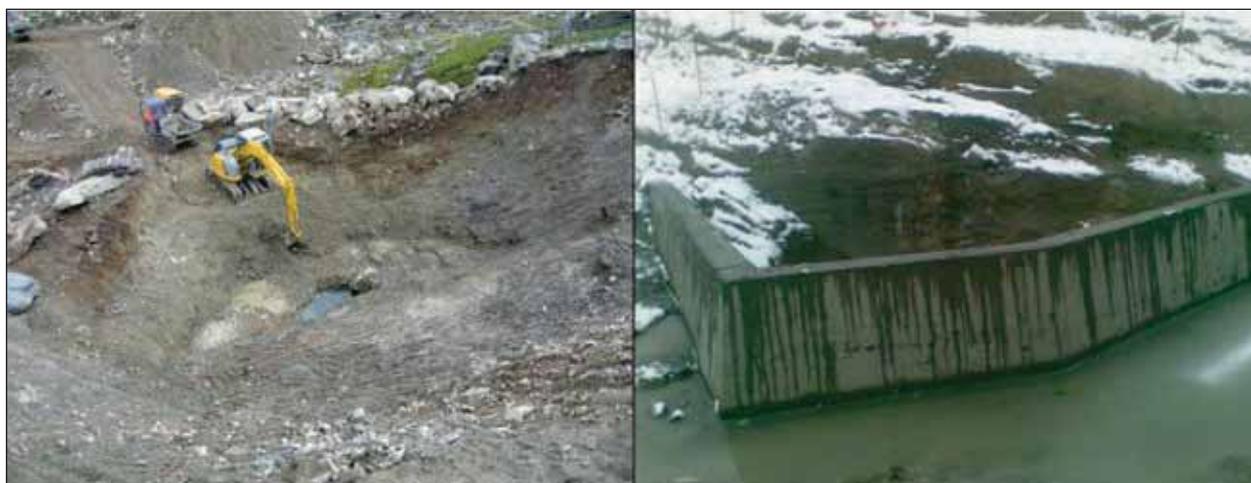
Fig. 4: Clearance and concrete protection wall at the sinkhole (Courtesy: Norsk Hydro).

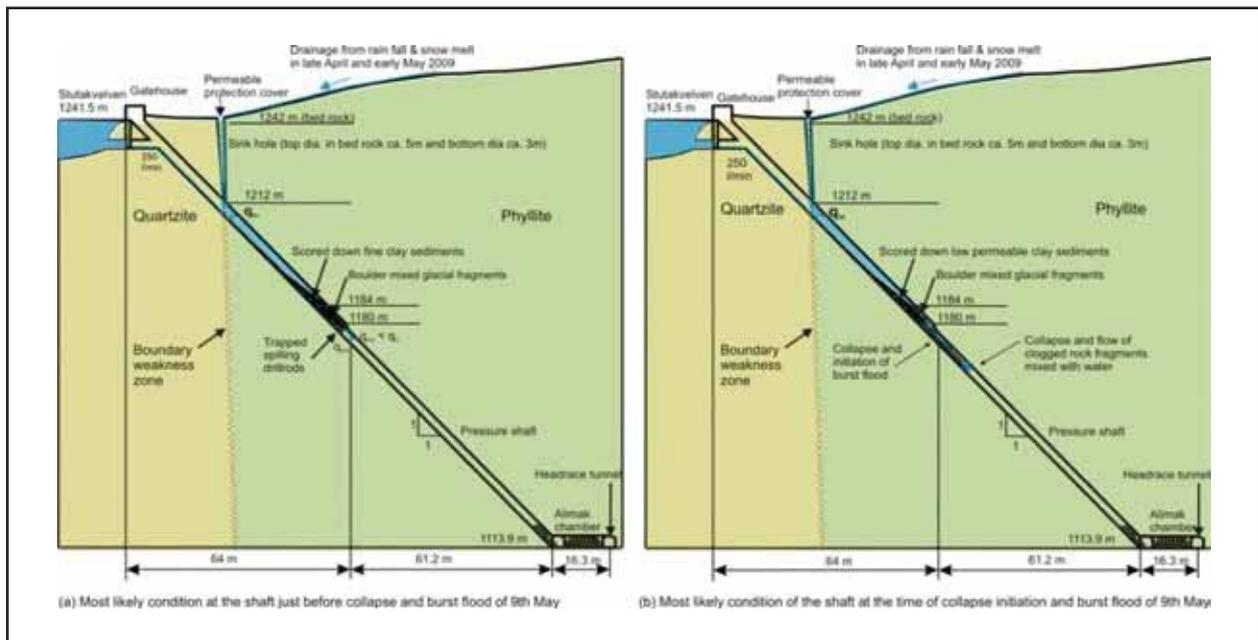
Fig. 5: Interpreted conditions of the Stutakvelven inclined shaft just before (a) and after the collapse of the clogged slide material (b) (Panthi, 2009 and 2012).
